Manhole Inspection Summary

Manhole # S63C__009MH

Insp Date: **5/29/08 11:44 AM**

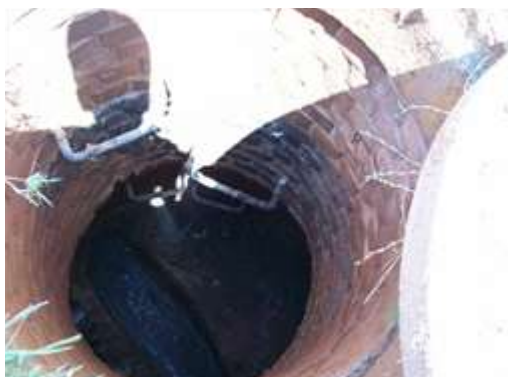
Defect 1

frame leaks

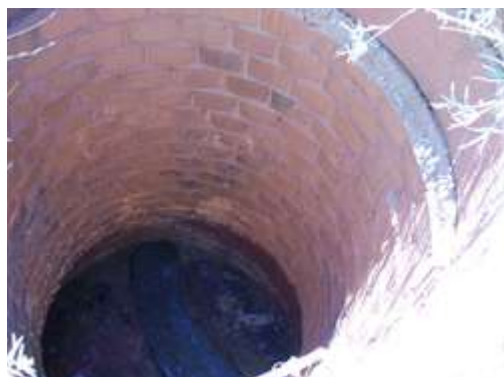
Defect 2

infiltration

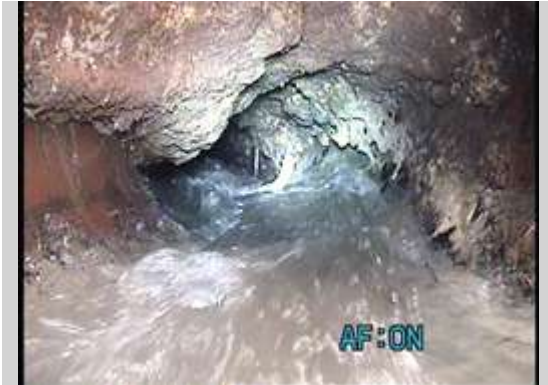
12 O'Clock Outflow

10 in. Circular Gravity Sewer
Pipe Out @ 12 O'Clock

Pipe Height: **10.8** (in.) Rod and Bar (Angled)
Pipe Material: **Clay** ☐ Pipe Lined
Invert Depth: **9.90** (ft.) Flow Characteristics: **Fast**
Deposits: ☒ None ☐ Mud ☐ Sludge ☐ Debris ☐ Grease
Silt Depth: (in.) Deposits Extent:
Infiltration: **None** Pipe Seal Cond: **Sound**

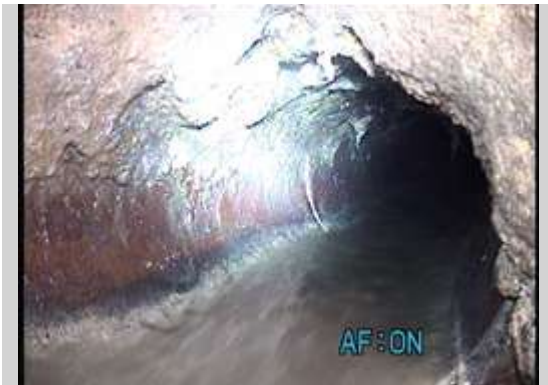
7 O'Clock Inflow

10 in. Circular Gravity Sewer
Pipe In @ 7 O'Clock

Pipe Height: **10.8** (in.) Rod and Bar (Angled)
Pipe Material: **Clay** ☐ Pipe Lined
Invert Depth: **9.55** (ft.) Flow Characteristics: **Fast**
Deposits: ☒ None ☐ Mud ☐ Sludge ☐ Debris ☐ Grease
Silt Depth: (in.) Deposits Extent:
Infiltration: **None** Pipe Seal Cond: **Sound**
